# ENGINE BEARING:

## FAILURE ANALYSIS AND CORRECTION

Technical information

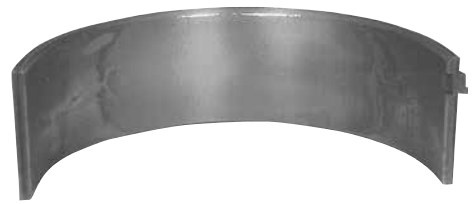
Uniform wear pattern over approximately 2/3 of the bearing's surface. Wear should diminish near the parting line ends of the bearing, and the wear pattern should extend uniformly across the bearing in the axial direction.

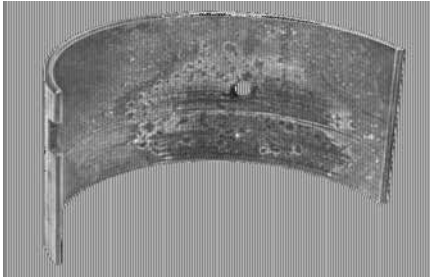
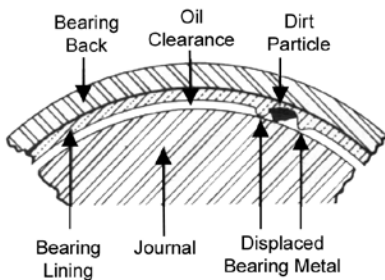
## 5 Foreign particles in lining

Foreign particles are embedded in the lining of the bearing. Scratch marks may also be visible on the bearing surface.

The high-spot may be large enough to make contact with the journal causing a rubbing action that can lead to the eventual breakdown and rupture of the bearing lining. Foreign particles may embed only partially and the protruding portion may come in contact with the journal and cause a grinding wheel action.

1. Improper cleaning of the engine and parts prior to assembly.
2. Road dirt and sand entering the engine through the air-intake manifold or faulty air filtration.
3. Wear of other engine parts, resulting in small fragments of these parts entering the engine's oil supply.
4. Neglected oil filter and/or air filter replacement.

1. Install new bearings, being careful to follow proper cleaning procedures.
2. Grind journal surfaces if necessary.
3. Recommend that the operator have the oil, air filter, oil filter and crankcase breather-filter replaced as recommended by the manufacturer.

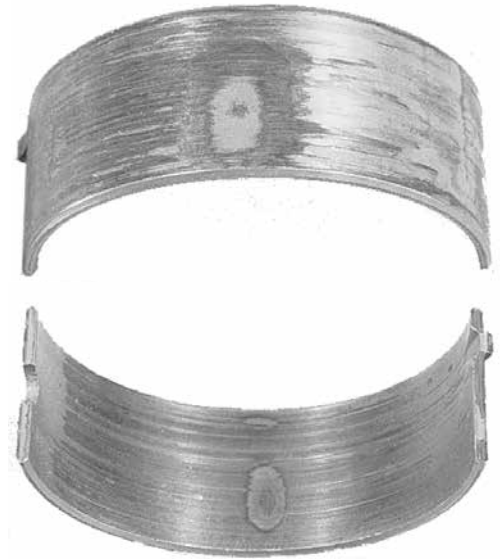
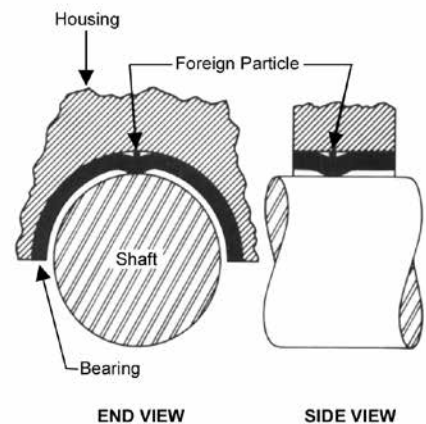
A localized area of wear can be seen on the bearing surface. Also, evidence of foreign particle(s) may be visible on the bearing back or bearing housing directly behind the area of surface wear.

Also, an uneven distribution of the load causes an abnormally high pressure area on the bearing surface, increasing localized wear on this material.

1. Install new bearings following proper cleaning and burr removal procedures for all surfaces.
2. Check journal surfaces and if excessive wear is discovered, regrind.

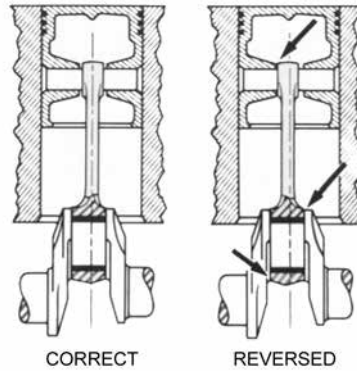
*Position of offset connecting rod reversed*

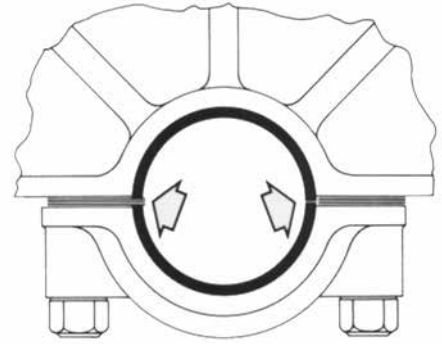
*Shims improperly installed*

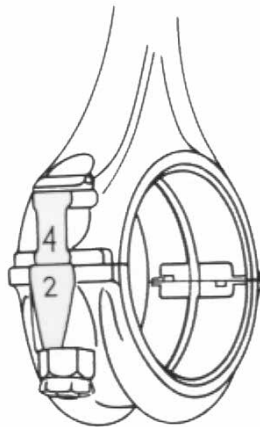
*Bearing caps in wrong or reversed position*

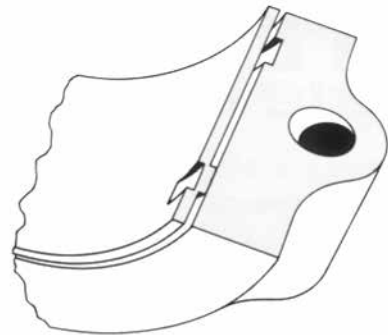
*Locating lug not nested*

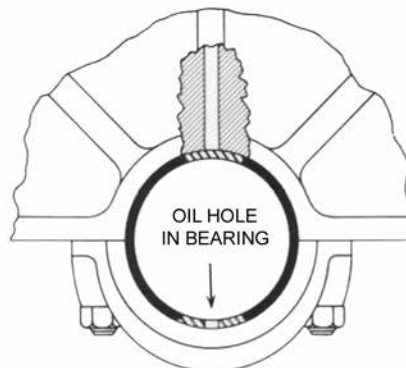
*Bearing halves reversed*

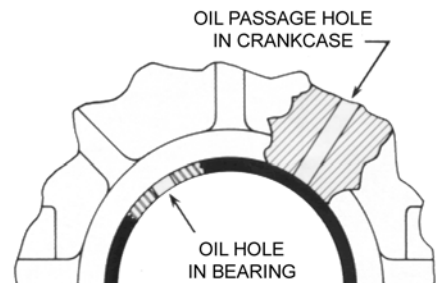
*Bearing oil hole not aligned with oil passage hole*

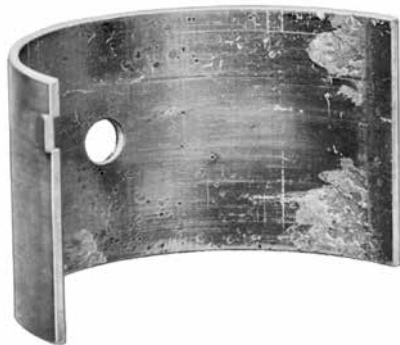
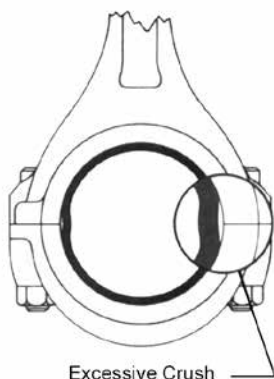
## 9 Excessive crush

Extreme wear areas visible along the bearing surface adjacent to one or both of the parting lines.

When there is too much crush, however, the additional compressive force created by the surplus crush that still remains after the bearing is fully seated causes the bearing to bulge inward at the parting faces. This bearing distortion is called "side pinch."

1. Rework the bearing housing of the engine block if it has been filed down.
2. Replace the connecting rod if its bearing cap has been filed down.
3. Check journal surfaces and regrind if necessary.
4. Install the new bearing and follow proper installation procedures by never filing down bearing caps and using the recommended torque wrench setting.
5. Correct the shim thickness (if applicable).
6. Check for out-of-roundness of the inside diameter of the assembled bearing by means of an out-of-roundness gauge, inside micrometer, calipers or prussian blue to assure that any out-of-roundness is within safe limits. The maximum assembled bearing I.D. should always be across the split line.

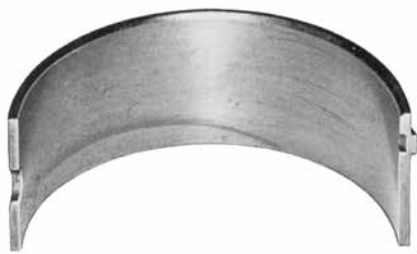
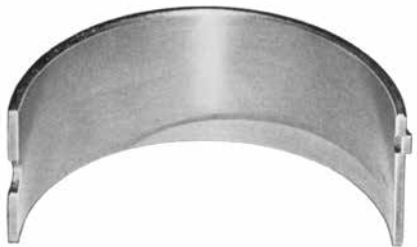
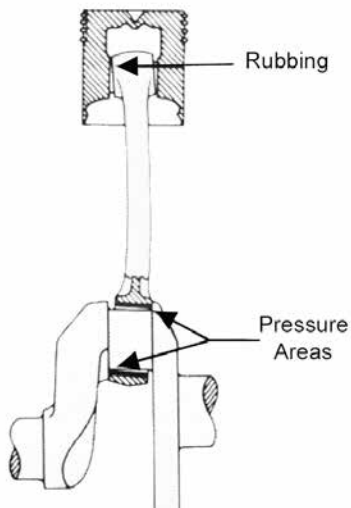
When fillet ride has caused a bearing to fail, areas of excessive wear are visible on the extreme edges of the bearing surface.

This metal-to-metal contact between the bearing and fillet causes excessive wear, leading to premature bearing fatigue.

1. Regrind the crankshaft paying particular attention to allowable fillet radii.  
NOTE: Be careful not to reduce fillet radius too much, since this can weaken the crankshaft at its most critical point.
2. Install new bearings with enlarged chamfers that allow proper fillet clearance.

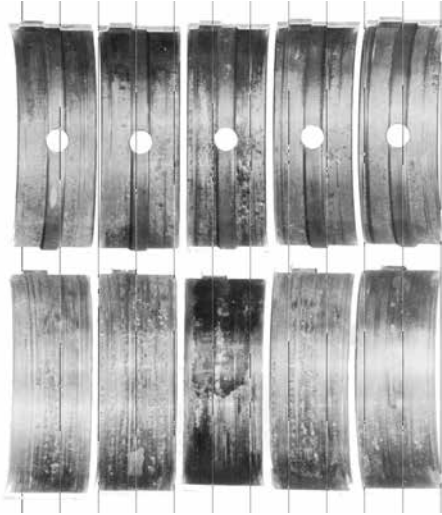
## 13 Distorted crankcase

A wear pattern is visible on the upper or lower halves of the complete set of main bearings. The degree of wear varies from bearing to bearing depending upon the nature of the distortion. The center bearing usually shows the greatest wear.

A distorted crankcase imposes excessive loads on the bearings, with the point of greatest load being at the point of greatest distortion. These excessive bearing loads cause excessive bearing wear. Also, oil clearance is reduced and metal-to-metal contact is possible at the point of greatest distortion.

Alternating periods of engine heating and cooling during operation is a prime cause of crankcase distortion. As the engine heats the crankcase expands, and as it cools, the crankcase contracts. This repetitive expanding and contracting causes the crankcase to distort over time in some situations.

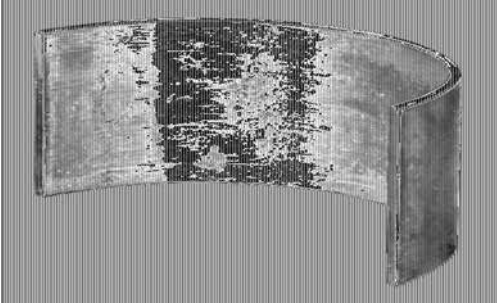
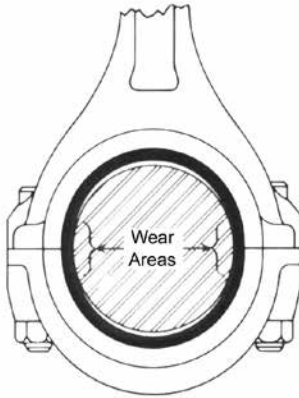
## 15 Out-of-round bore

Localized excessive wear areas are visible near the parting line on both top and bottom shells.

Oil clearance near the parting line is decreased to such an extent that metal-to-metal contact between bearing and journal takes place, resulting in areas of above-normal wear.

Also, improper seating between the bearing back and the housing bore may be present which hinders proper heat transfer causing localized heating of the bearing surface and thus reducing fatigue endurance.

Alternating loading and flexing of the connecting rod can cause the bearing housing to become elongated. And because replacement bearing shells, when installed, tend to conform to the shape of the bearing housing, this can result in an out-of-round bearing surface.

1. Check the roundness of bearing housings before installing the new bearings. If they are found to be out-of-round, recondition the bearing housings (or replace connecting rod).
2. Check the journal surfaces for excessive wear and regrind if necessary.
3. Install new bearings.

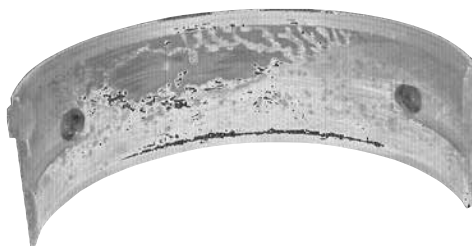
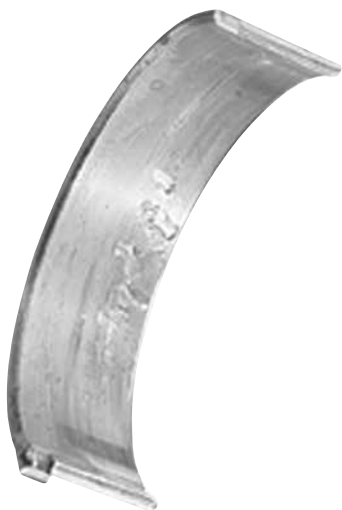
## 19 Surface fatigue

Bearing surface cracked, small irregular areas of surface material missing from the bearing lining.

Heavy pulsating loads imposed upon the bearing by reciprocating motion within the engine cause the bearing surface to crack due to metal fatigue.

Fatigue cracks widen and deepen perpendicular to the bond line. Close to the bond line, fatigue cracks turn and run parallel to the bond line, eventually joining and causing pieces of the surface to flake out.

1. Overloading (lugging, detonation, or overfueling).
2. Uneven loading (see sections on misalignment).
3. Bearing material of inadequate fatigue strength for application.
4. Bearing failure due to surface fatigue can be the result of the normal life span of the bearing being exceeded.

1. If the service life for the old bearing was adequate, replace with the same type of bearing to obtain a similar service life.
2. If the service life of the old bearing was too short, replace with a heavier duty bearing to obtain a longer life.
3. Replace all other bearings (main connecting rod and camshaft) as their remaining service life may be short.
5. Check for misassembly. Use proper installation techniques.

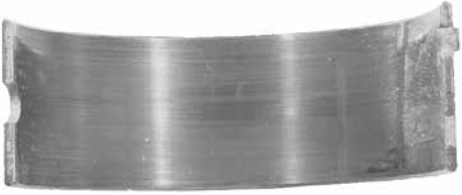
## 21 Accelerated wear

Wall thickness reduced from original dimension. Bearing surface worn and polished but not smeared, torn or scored. No evidence of heat, no embedded foreign particles.

Grinding and polishing the crankshaft journals produce burrs that are so small that we can't see or feel them. Not only is it important that the surface finish meet recommended average Ra or better, but it is also important to always grind opposite to rotation and polish in the direction of rotation. Otherwise it is possible for these microscopic burrs to disrupt the oil film and abrade away the bearing surface.

1. Poor journal surface finish.
2. Wear in the presence of adequate lubrication to prevent heat build-up and wiping is caused by peaks in the journal surface finish profile which penetrate the oil film and abrade the bearing.

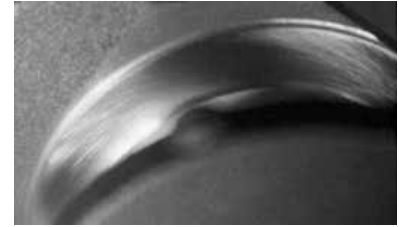
Obtaining a good finish on the thrust face of a crankshaft is difficult to do because it uses side-wheel grinding. Side grinding causes marks that spiral outward toward the OD of the thrust face and may also cause crosshatch marks resembling honing patterns. Both patterns are detrimental to the formation of an oil film because they work like wipers as the shaft rotates. Grinding marks must be removed by polishing. Only a circular pattern should remain. Surface finish should be checked in a tangential direction and must be held to 10 Ra max. The thrust surface should be flat within .0002” max.

*avoid - swirl pattern*
