# ENGINE BEARING:

## FAILURE ANALYSIS AND CORRECTION

Technical information

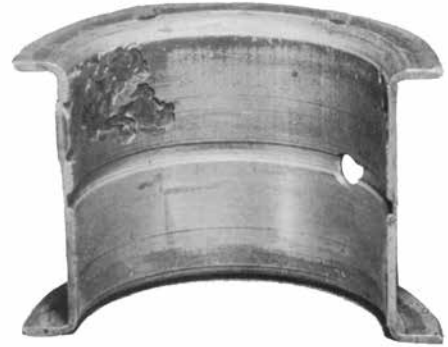
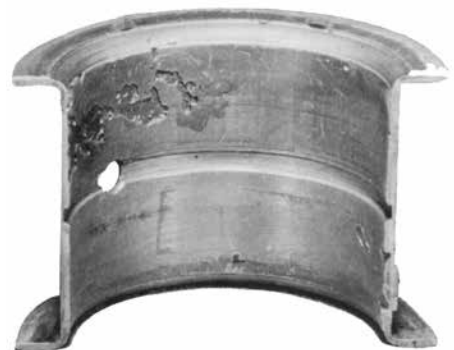
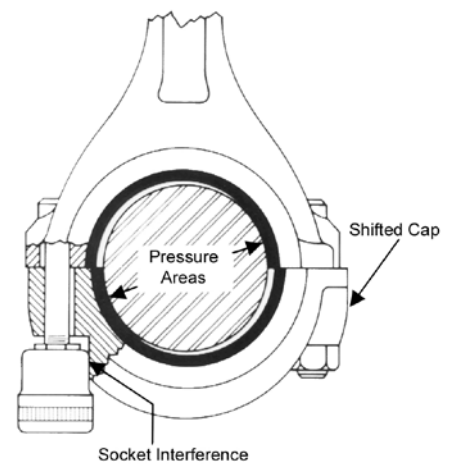
Excessive wear areas can be seen near the parting lines on opposite sides of the upper and lower bearing shells.

The resulting metal-to-metal contact and excessive pressure cause deterioration of the bearing surface and above normal wear areas.

1. Using too large a socket to tighten the bearing cap. In this case, the socket crowds against the cap causing it to shift.
2. Reversing the position of the bearing cap.
3. Inadequate dowel pins between bearing cap and housing (if used), allowing the cap to break away and shift.
4. Improper torquing of cap bolts resulting in a "loose" cap that can shift positions during engine operation.
5. Enlarged cap bolt holes or stretched cap bolts, permitting greater than normal play in the bolt holes.

1. Check journal surfaces for excessive wear and regrind if necessary.
2. Install the new bearing being careful to use the correct size socket to tighten the cap and the correct size dowel pins (if required).
3. Alternate torquing from side to side as to assure proper seating of the cap.
4. Check the bearing cap and make sure it's in its proper position.
5. Use new bolts to assure against overplay within the bolt holes.

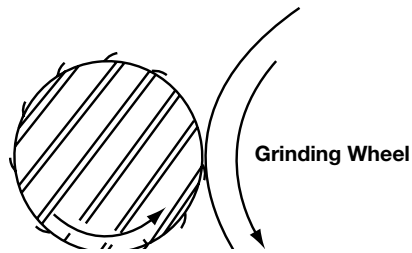
Fig. 4  
Directions of shaft and grinding wheel rotation and lay of  
fuzz which results

Having determined the desired surface lay from polishing, we must next establish the proper direction for grinding to produce a surface lay opposite to that resulting from polishing. Figure 4 shows the grinding wheel and shaft directions of rotation and surface lay for grinding when viewed from the front or nose end of the crankshaft. This orientation will be achieved by chucking the flywheel flange at the left side of the grinder (in the headstock). Achieving the best possible surface finish during grinding will reduce the stock removal necessary during polishing.

The surface lay generated by grinding would cause abrasion to the bearing surfaces if left unpolished. By polishing in the direction shown in figure 3, the surface lay is reversed by the polishing operation removing fuzz created by grinding and leaving a surface lay which will not abrade the bearing surface.
